Manhole Inspection Summary

Manhole # S23CC2001MH

Insp Date: **11/28/06 3:28 PM**

Location Address: **911 SAINT GEORGES RD**

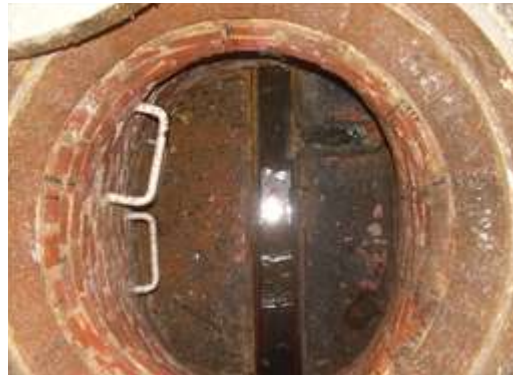
Top View

Evidence of surcharge - Bench debris.
Channel debris.

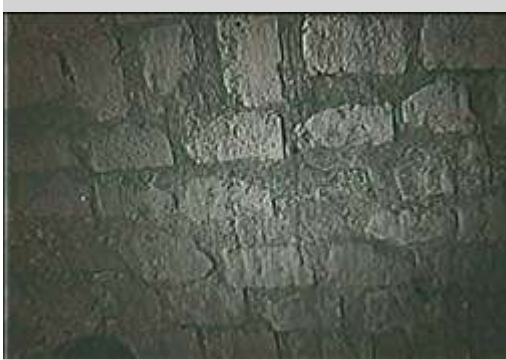
Defect

Barrel deterioration and infiltration.

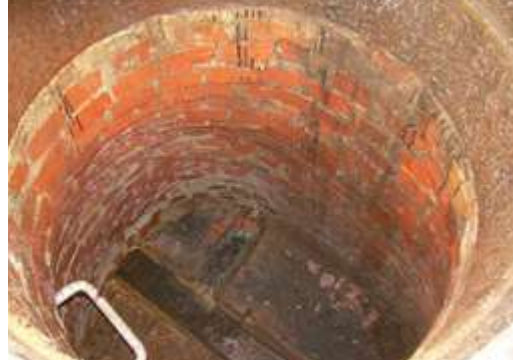
Defect

Frame leaks. Adjustment and Barrel
infiltration.

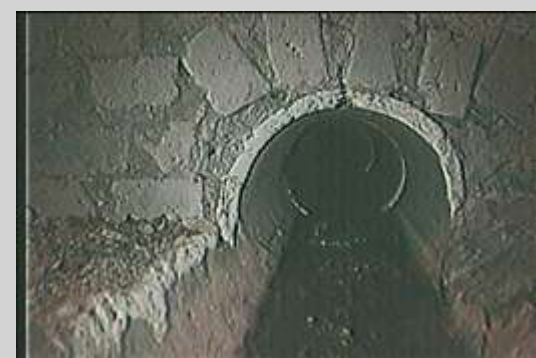
8 in. Circular Gravity Sewer Pipe Out @ 12 O'Clock

Channel cracks.

Infiltration: **None** Pipe Seal Cond: **Cracked**

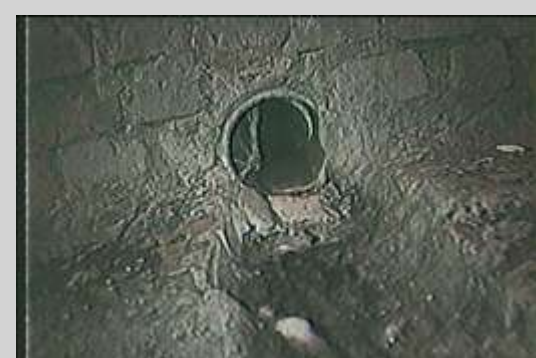
4 in. Circular Gravity Sewer Pipe In @ 3 O'Clock

Barrel deterioration and infiltration. Channel deterioration.

Infiltration: **Evidence** Pipe Seal Cond: **Cracked**

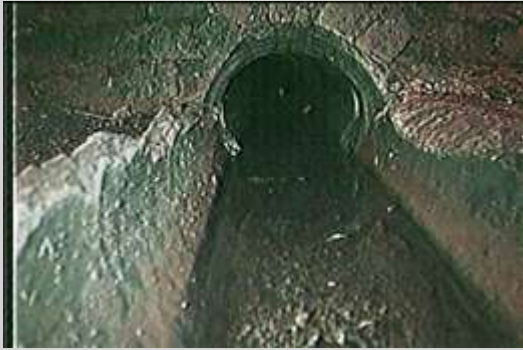
Pipe In @ 6 O'Clock

Infiltration: **Evidence**
